### TRANSPORTATION SCIENCES CENTER ACCIDENT RESEARCH GROUP

CALSPAN ON-SITE AIR BAG/CHILD PASSENGER FATALITY INVESTIGATION
CALSPAN CASE NO.-CA94-45 CA96 QP
VEHICLE - 1995 HYUNDAI ACCENT
LOCATION - FLORIDA
CRASH DATE - 1996

Contract No. DTNH22-94-D-07058

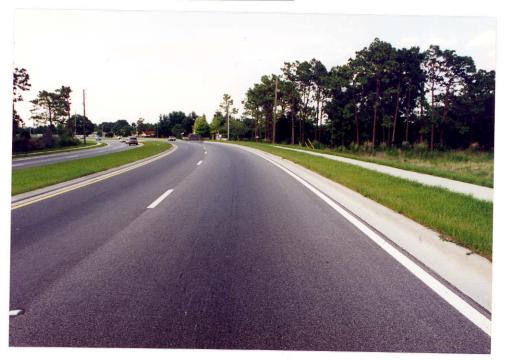
1. Pre-crash trajectory of the 1995 Hyundai Accent.

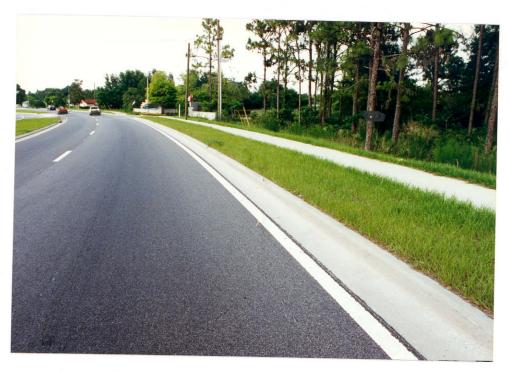
5. Remainder of the right rear tire mark on the road surface.

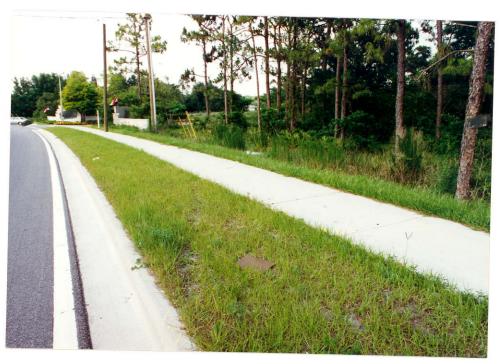
6. Hyundai mounts barrier curb and traverses grassy area and sidewalk in a CW yaw.

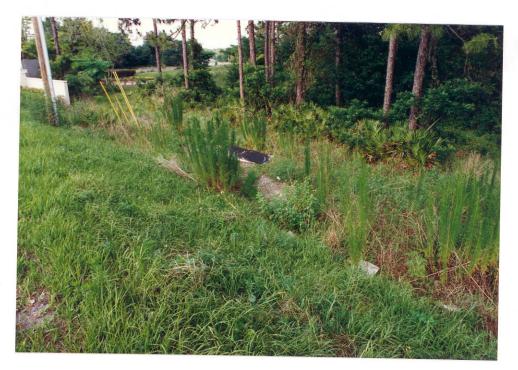
7. Vehicle traverses embankment leading with left side.

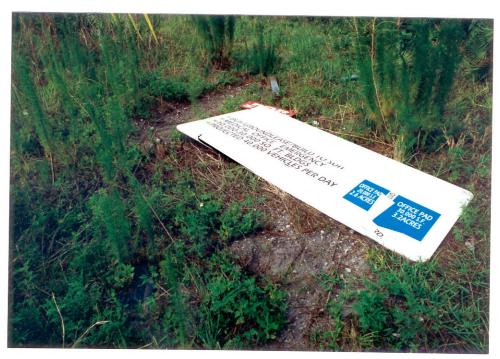
8.  $1.2 \times 2.4 \text{ m}$  (4 x 8') sign struck by left side of vehicle.

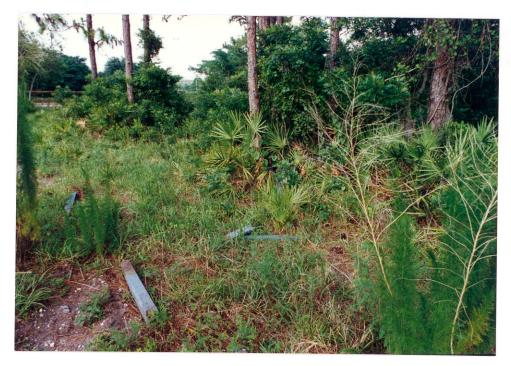
impacts were located on the left front fender at the A-pillar and at the left rear door and C-pillar. The 3 o'clock impact force fractured the posts at ground level as the vehicle overturned onto its roof. The Hyundai subsequently slid on its roof for approximately 7.9 m (26.0') before impacting a 22.9 cm (9.0") diameter tree with the right A-pillar area. The non-horizontal impact produced 25.4 cm (10.0") of crush to the right A-pillar at the beltline elevation. The Hyundai rotated from the tree and came to rest approximately 4.0 m (14.0') beyond the struck tree.

9. Fractured 10 x 10 cm (4 x 4") wooden sign posts.

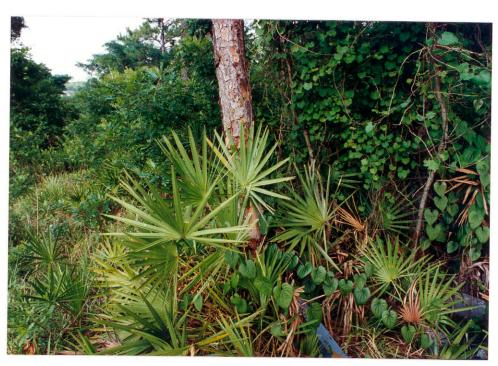
The Hyundai slid on its roof into a 22.9 cm (9.0") diameter tree (Event No. 6). The non-horizontal impact involved the right A-pillar area of the vehicle. The direct contact damage from the tree impact began 173.0 cm (68.1") forward of the right rear axle and extended 24.1 cm (9.5") forward. The lateral extent of maximum crush was 28.3 cm (11.1") that was located on the right door 7.6 cm (3.0") rearward of the right A-pillar. The combined induced and direct contact damage began at the trailing edge of the left front door and extended 152.4 cm (60.0") forward to the mid aspect of the right front fender. The crush profile at mid door level was as follows: C1=0 cm, C2=3.8 cm (1.5"), C3=19.7 cm (7.75"), C4=36.8 cm (14.5"), C5=2.9 cm (1.1"), and C6=0 cm.

10. Struck 23 cm (9") diameter tree.

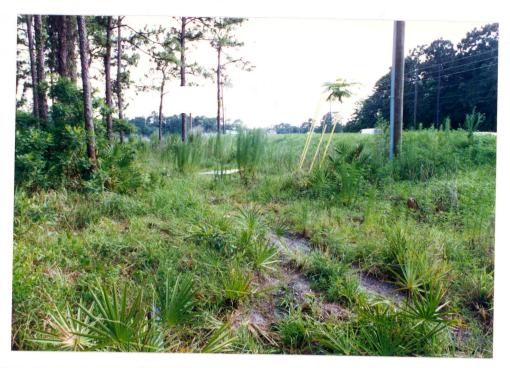
11. Vehicle's final rest position in foreground and lookback view of overall trajectory.

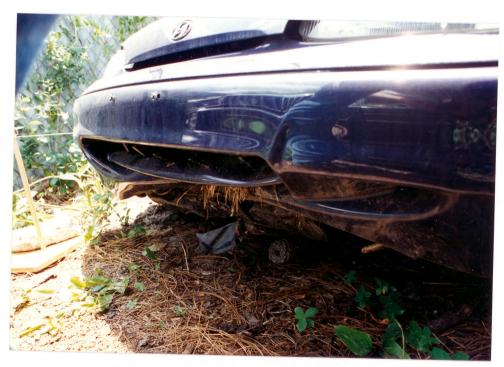
As the Hyundai mounted the barrier curb and traversed the grassy area and concrete sidewalk, the vehicle traveled down the earth embankment in a CW yaw and gouged the embankment with the front undercarriage area. The undercarriage contact (Event No. 3) involved the engine shield that was mounted between the lower bumper fascia and the front crossmember, and the integral valance/air dam of the front bumper fascia. Direct contact damage consisted of abrasions with embedded dirt and vegetation. The damage began 61.0 cm (24.0") left of center and extended 114.3 cm (45.0") across the frontal width of the vehicle. The sheetmetal engine shield was displaced approximately 8.9 cm (3.5") in both an upward and rearward direction. The valance area of the bumper fascia was displaced vertically by the engine shield deformation, however, there was no structural involvement of the bumper assembly. A tie-down bracket was affixed to the leading edge of the undercarriage at the mid point of the vehicle. As a result of the undercarriage contact, the tie-down bracket was deformed in an upward direction and was partially separated from the undercarriage mounting point. This damage is documented in Photograph No.14.

14. Frontal undercarriage damage from embankment contact.

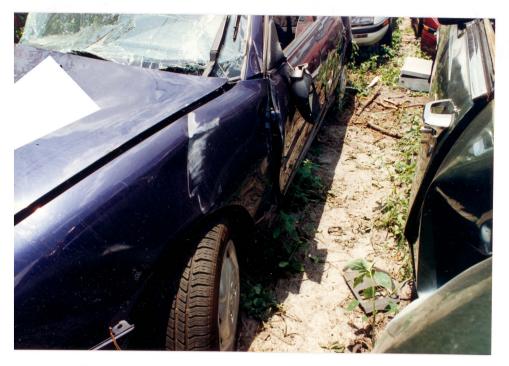
sign posts on a lateral travel path which resulted in a 9 o'clock impact force. The vehicle's impact sequence with the two sign posts resulted in four distinct impact patterns to the left side of the vehicle. This resulted from the vehicle's angular approach to the sign posts and the initial impact and penetration through the posts as the wooded posts fractured at multiple points. These patterns consisted of gray paint transfers with underlying superficial damage to the sheetmetal and glazing areas. The first point of contact was located on the left front fender and extended 1.3-22.2 cm (0.5-8.75") rearward of the left front axle position. The gray paint transfer extended vertically across the left front wheel cover and onto the fender directly over the tire. Due to the initiation of the roll and the fracturing of the wooden post, the transfer extended onto the top horizontal surface of the fender, ending 1.3 cm (0.5") onto the hood. Maximum crush was 1.9 cm (0.75") and was located at the upper surface of the fender 6.4 cm (2.5") rearward of the referenced axle. Photograph No. 15 documents this impact point.

The second contact point from the sign post was located on the left A-pillar 41.3-58.4 cm (16.25-23.0") rearward of the left front axle. The gray paint transfer began at the trailing edge of the fender 27.9 cm (11.0") above the ground and extended 17.8 cm (7.0") vertically to a stop point and continued 54.6-94.0 cm (21.5-37.0") above the ground onto the upper A-pillar. The transfer extended across the juncture of the fender and left front door. Maximum crush was 1.3 cm (0.5") located at the mid point of the trailing edge of the left front fender. Photograph No. 15 documents the damage. It should be noted that the depth of crush appears to be understated. This is due to lateral shifting of the frontal structure from an additional impact sequences that involved a right side tree impact and the subsequent rollover.

15. Sign post impact damage on left front fender and A-pillar.

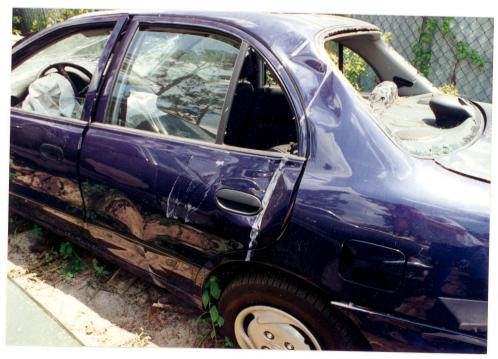
The second sign post damage pattern was located on the left rear door and C-pillar area. The initial contact damage was a narrow gray paint transfer which began 228.6-241.9 cm (90.0-95.25") rearward of the left front axle and extended vertically across the left rear wheel cover, onto the left rear quarter panel and door panel at the rear edge of the door handle, across the left rear quarter window and door window frame, and onto the upper C-pillar. The sheetmetal contact resulted in 3.8 cm (1.5") of crush located at the rear edge of the door handle and 2.0 cm (0.8") of crush at the upper C-pillar. The fixed quarter window glazing was shattered by the post contact. This damage pattern is documented in Photograph Nos. 16 and 17.

(12.75") to the beltline of the Hyundai. At this level, the transfer was located 193.7-215.3 cm (76.25-84.75") rearward of the front axle position and resulted in superficial sheetmetal damage. The post contact extended across the quarter window and onto the C-pillar and roof, resulting in 1.0 cm (0.4") of crush at the C-pillar area. This contact damage patten is documented in Photograph Nos. 16 and 17.

16. Sign post impact damage on left rear door and C-pillar.

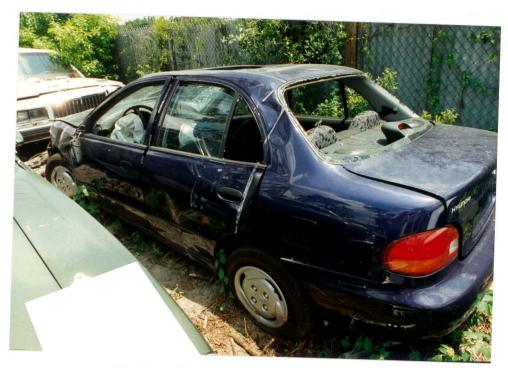
17. Overall left side view of the Hyundai.

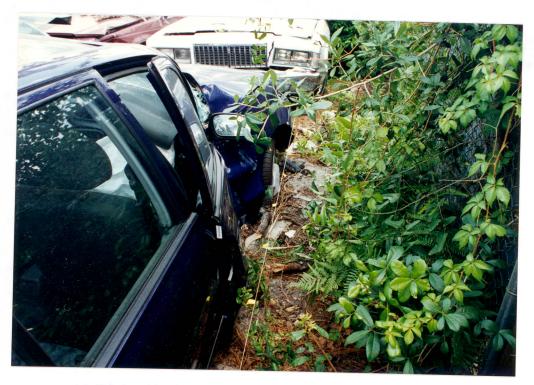
19. Right side damage that resulted from the tree impact.

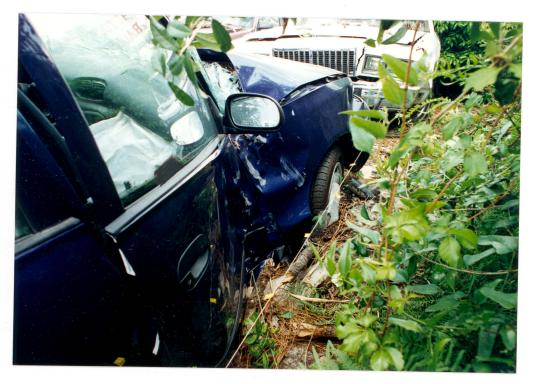
20. Tree impact damage at the right A-pillar area.

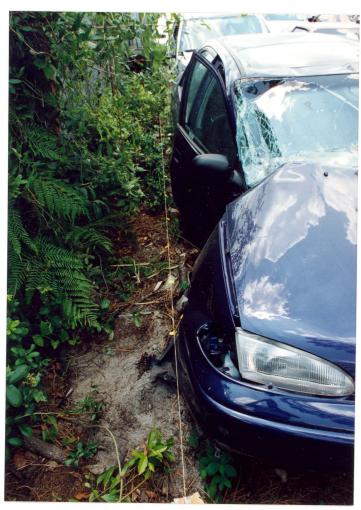
22. Longitudinal view documenting the extent of lateral crush at the right A-pillar.

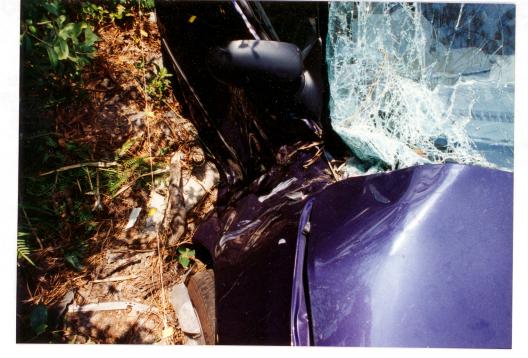
23. Close-up view of the tree impact damage.

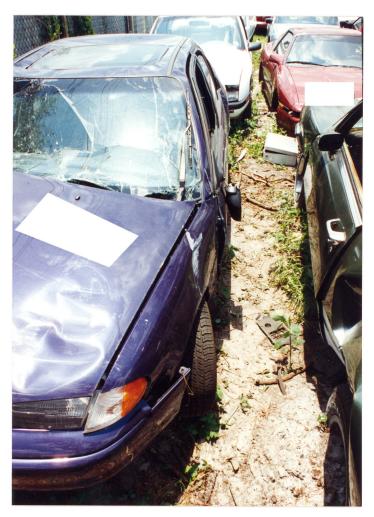
24. Lateral displacement of the frontal structure that resulted from the right side tree impact.

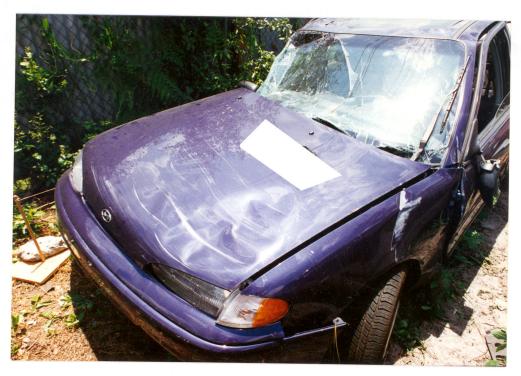
The Hyundai subsequently initiated a lateral rollover sequence to its left which resulted in minimal left side contact damage before rolling onto its roof (Event No. 5). Vertically oriented abrasions were noted to the left front fender which extended 71.1 cm (28.0") rearward of the leading edge. The left A-pillar mounted rear view mirror was fractured from its mount as a result of the rollover, however, there was no contact damage to the left side doors or rear quarter panel. As the Hyundai rolled onto its roof, superficial dents and laterally oriented abrasions were present on the hood. This contact damage began at the left hood edge, 63.5 cm (25.0") left of center and extended to a point 33.0 cm (13.0") right of center. The superficial damage extended 58.4 cm (23.0") rearward from the hood face. The abrasions from the rollover sequence extended 96.6 cm (38.0") rearward of the left Apillar/windshield header juncture onto the left roof side rail. As the Hyundai overturned onto its roof, superficial abrasions extended across the full length (101.6 cm) and width (134.6 cm) of the roof panel. Maximum crush was 3.8 cm (1.5") located at the mid rear seat area 88.9 cm (35.0") rearward of the windshield header. The tempered glass sunroof remained closed and intact during the rollover sequence. There was no contact damage on the trunk lid of the vehicle.

25. Rollover contact damage across the hood of the Hyundai.

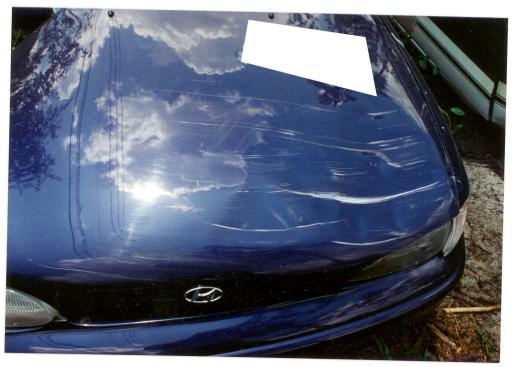
26. Close-up view of the laterally oriented abrasions.

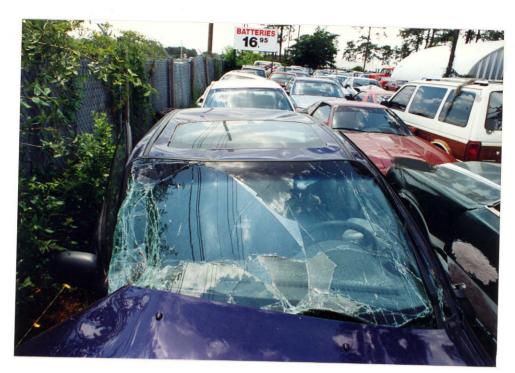
27. Minimal roof crush from the rollover event.

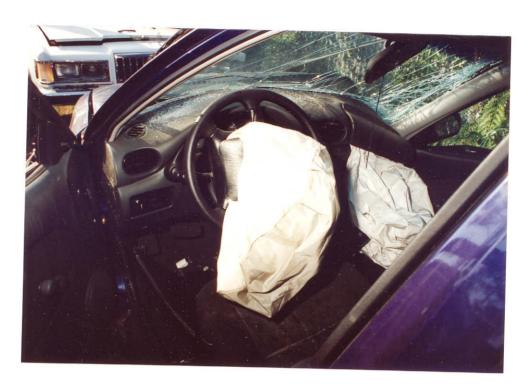
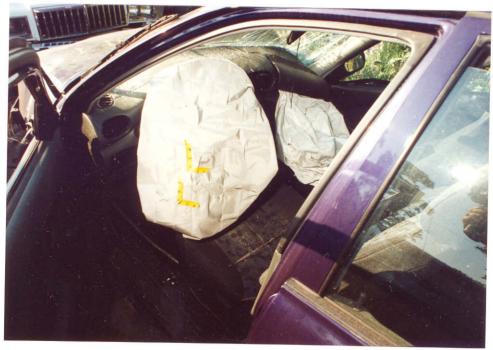
The interior of the Hyundai Accent sustained moderate damage that was associated with exterior deformation, intrusion of interior components, and deployment of the supplemental air bag system. The intrusion resulted from lateral displacement of the right A-pillar and door from the non-horizontal impact with the tree (Event No. 6). Maximum intrusion involved 14.0 cm (5.5") of lateral displacement of the right mid A-pillar which compressed the right instrument and rotated the passenger side air bag module assembly (refer to Photograph No. 52). The glove box door subsequently opened as a result of A-pillar displacement and panel compression.

The supplemental driver and passenger side air bag system deployed as designed from the respective module assemblies. The driver's face contacted the deployed driver's side bag as evidenced by lipstick transfers on the face of the bag. The passenger side air bag fabric expanded against the rearward facing child restraint. As a result of expansion against the infant restraint, fabric transfers were present on the bag fabric from the lining of the infant restraint. There was no damage to the air bag fabrics.

29. & 30. Overall views of the vehicle's interior and the deployed air bags.

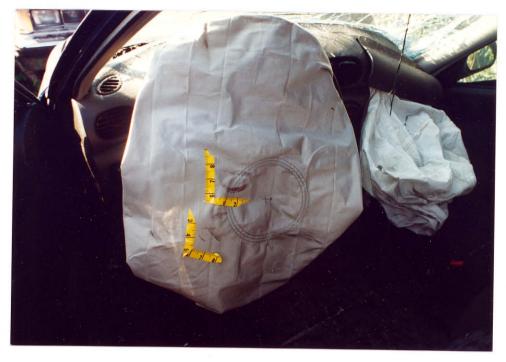
There was no damage (i.e., tears, abrasions, burns) to the deployed driver's side air bag. Driver facial contact with the deploying air bag resulted in lipstick transfers to the lower center area of the bag. The transfers were vertically oriented on the air bag (refer to Photograph Nos. 31 and 32) which indicated the steering wheel was rotated approximately 90 degrees in a clockwise direction as the SRS deployed. Irregular purple shade transfers were located 1.3-6.4 cm (0.5-2.5") right of the vertical centerline of the bag and 7.6-12.7 cm (3.0-5.0") below the horizontal centerline. These lipstick transfers consisted of four distinct marks that were located directly outboard of the tether reinforcement stitching. The most pronounced lipstick transfer was located 3.8-9.5 cm (1.5-3.75") below the horizontal centerline and 1.9-5.7 cm (0.75-2.25") left of center. As documented on Photograph No. 32, the upper and lower lipstick transfers were separated by 2.3 cm (0.9").

31. Driver lipstick transfers on the deployed driver's side air bag.

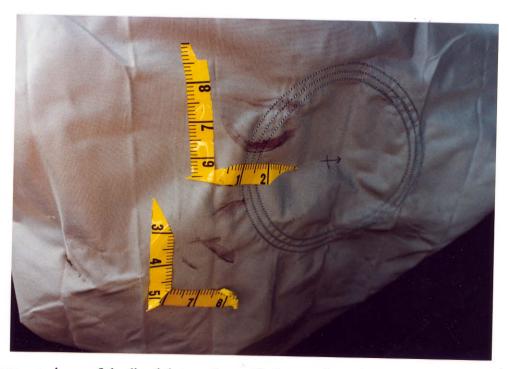
32. Close-up views of the lipstick transfers with the steering wheel rotated 90 degrees CW.

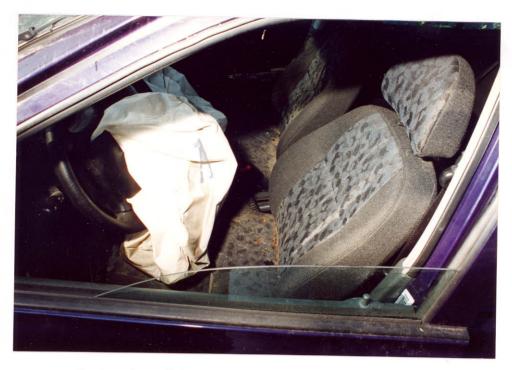
37. Perpendicular view of the deployed driver's side air bag and driver's seat.

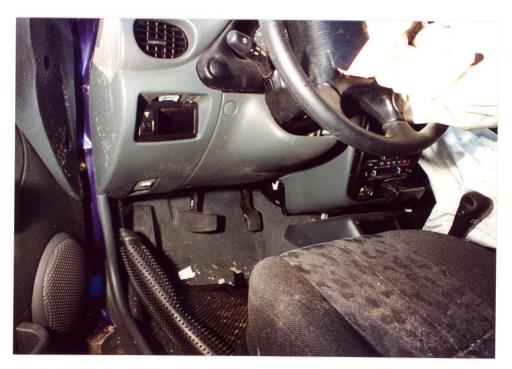
38. Driver's side knee bolster (no contact evidence) and deformed brake pedal.

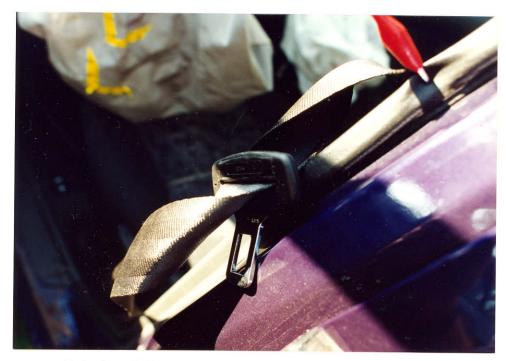
the polymer covering of left front latchplate was abraded from belt interaction (driver loading) against the latchplate (refer to Photograph Nos. 43 and 44). Minimal routine wear marks were noted to the male tab of the latchplate.

43. Belt webbing abrasions to the plastic latchplate cover.

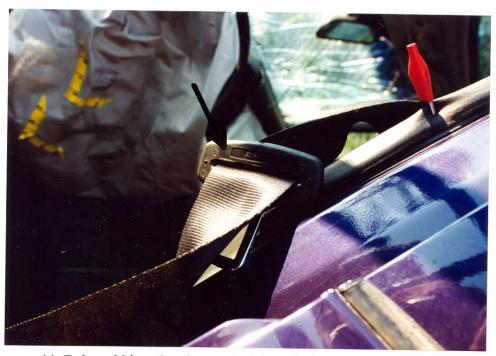
44. Belt webbing abrasion at the inboard slot of the latchplate.

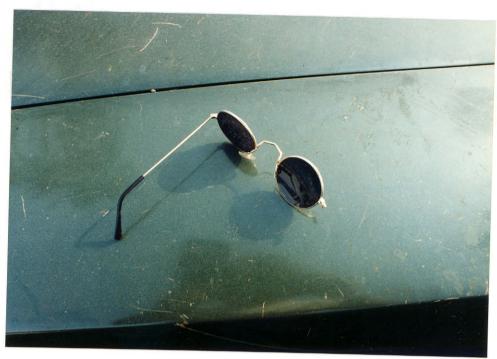
The driver was wearing blue cotton shorts, a black short-sleeve blouse, and sandals at the time of the crash. In addition, she was wearing a wristwatch on her left wrist, two rings on each hand, and wire framed sunglasses. She did not report damage to her clothing or accessories, however, the driver noted that she lost her sunglasses during the crash. The driver's face contacted the deploying air bag which deformed the sunglasses and separated the eyeware from her face. The sunglasses were found on the right front floor of the vehicle. Damage to the glasses included bending of the frames and separation (fractured from hinge) of the right ear arm (refer to Photograph No. 45).

45. Deformed sunglasses worn by the driver of the Hyundai.

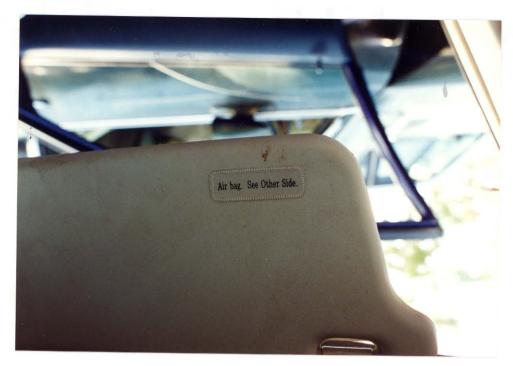
Air bag advisory labels were affixed to the sunvisors. On the bottom (exposed) side of the visor, at the rear inboard corner, was a label that measured  $5.1 \times 1.3 \text{ cm } (2.0 \times 0.5")$  which noted the following (refer to Photograph No. 47): Air Bag. See Other Side.

47. Close-up view of the advisory label

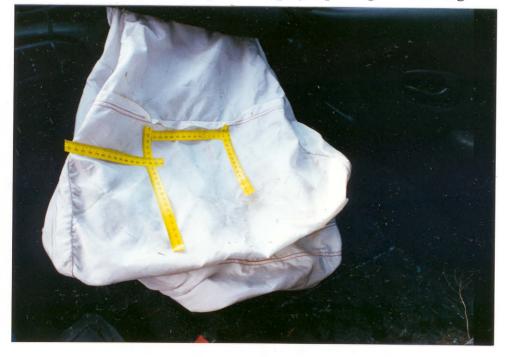
There was no damage to the passenger side air bag and/or the module cover assembly, however, fabric transfers from the rearward facing child restraint were noted to the upper aspect of the bag. A vertically oriented red fabric transfer was located 2.5-12.7 cm (1.0-5.0") below the upper seam (refer to Photograph No. 56). A faint blue fabric transfer was located 14.0-20.3 cm (5.5-8.0") left of the bag's centerline and 5.1-21.6 cm (2.0-8.5") below the referenced seam.

56. Probable fabric transfers from the rearward-facing child restraint.

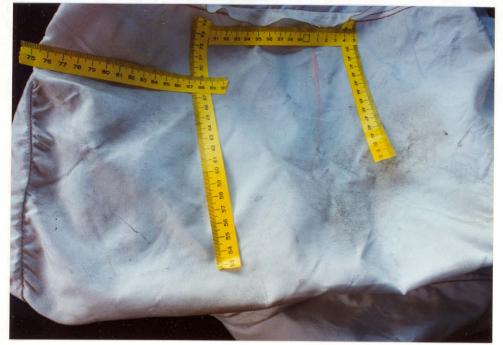
57. Close-up view of the probable fabric transfers.

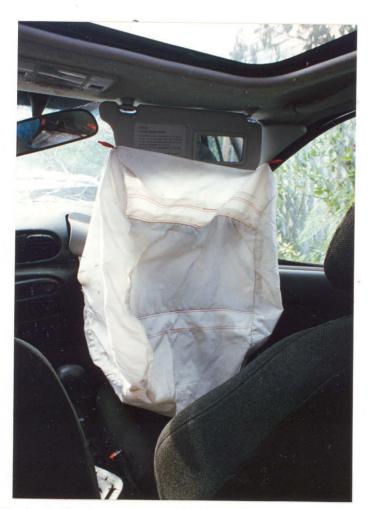
58. Horizontal tether seams on the face of the passenger side air bag.

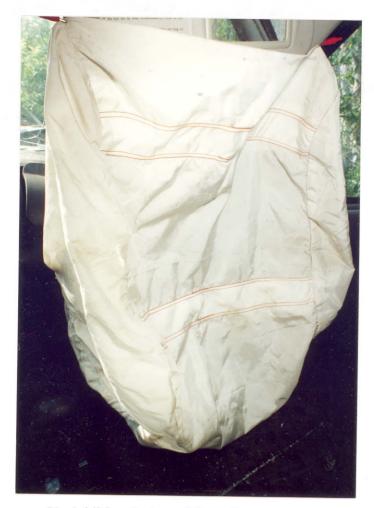
59. Additional view of the tether seams.

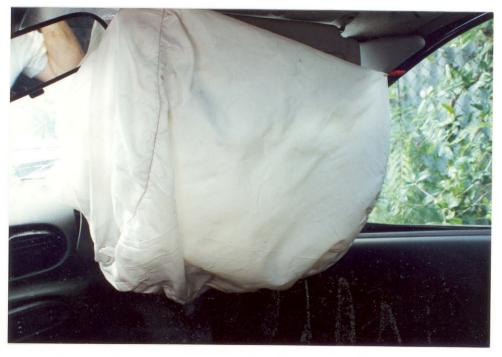
60. Underside of the passenger side air bag.

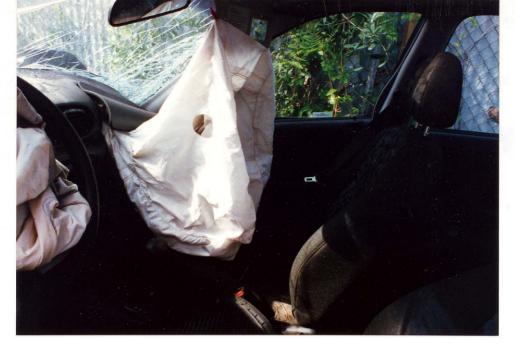
61. Perpendicular view of the deployed passenger side air bag.

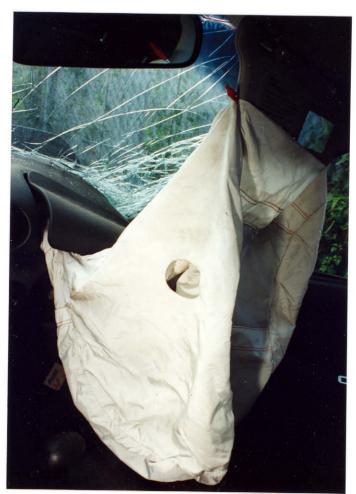
62. Inboard 5.1 cm (2.0") diameter vent port.

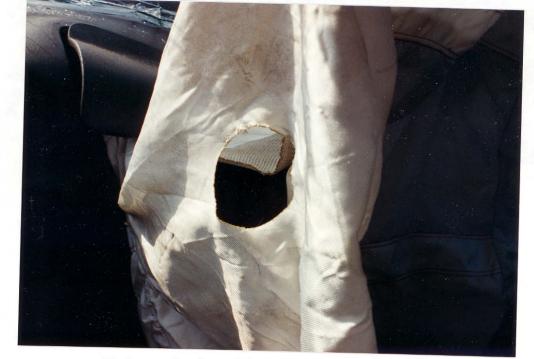
63. Internal tether of the passenger side air bag.

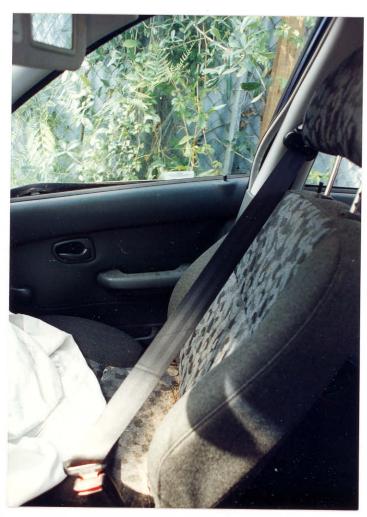
64. Extended passenger side shoulder belt webbing.

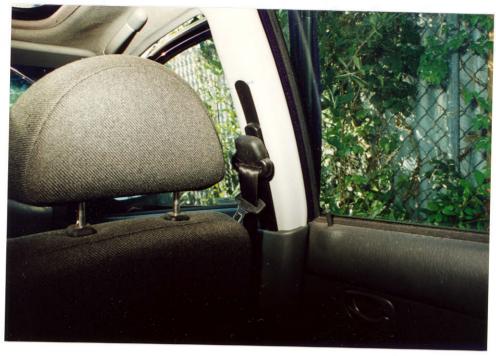
65. Adjustable upper anchorage (D-ring) of the passenger side belt system.

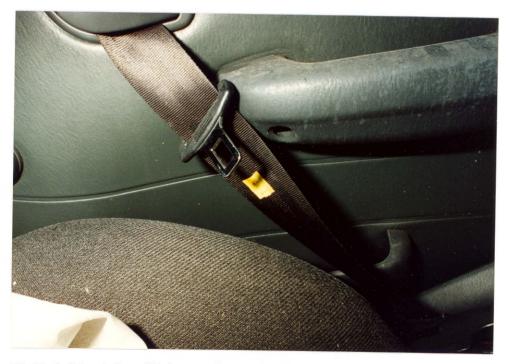
66. Probable air bag fabric transfer on the right front shoulder belt webbing.

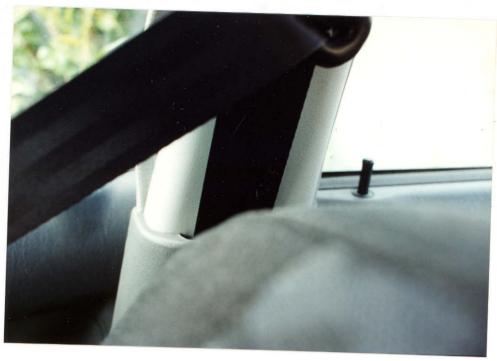
67. Circular transfers on the right front shoulder belt webbing.

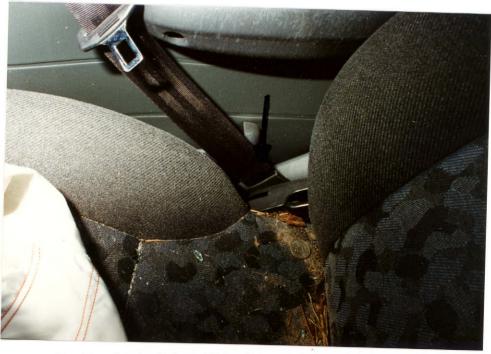
68. Abrasion on belt webbing from plastic extrusion located at the outboard aspect of the right front seat cushion/seat back juncture.

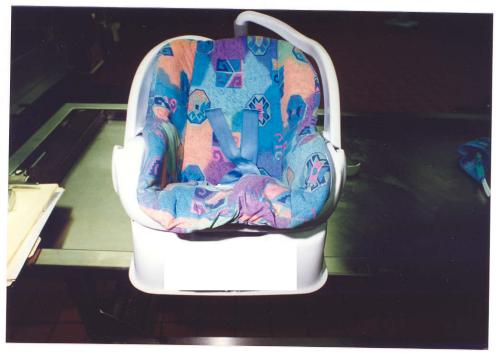
69. Frontal view of the Evenflo On My Way infant restraint.

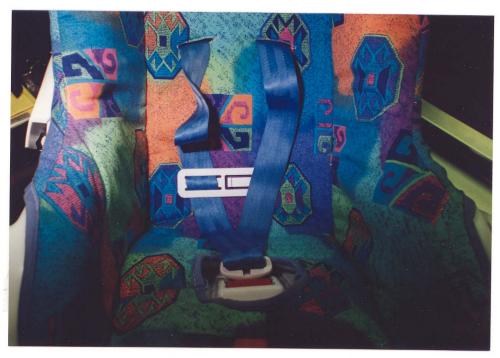
70. Integral 3-point harness of the restraint.

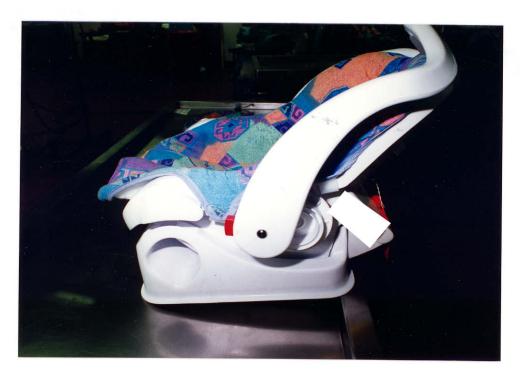
71. Left side view of the restraint positioned in the removable base unit.

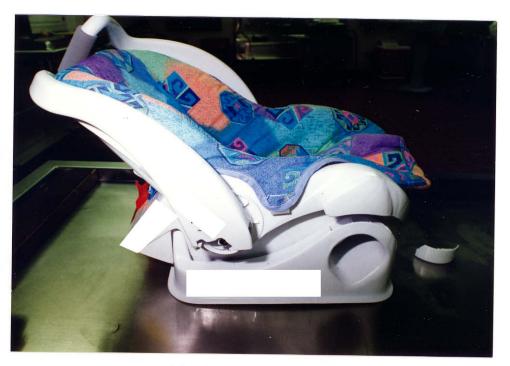
72. Right side view of the restraint.

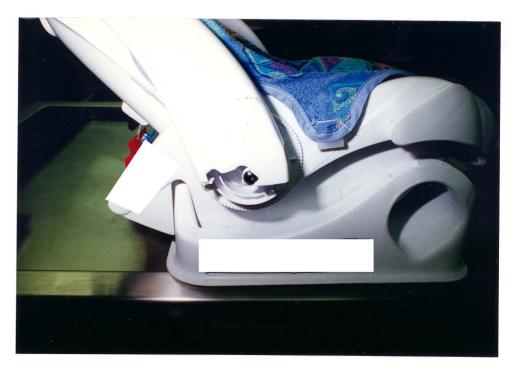
pivot points and fractured the left side pivot, partially separating the handle from the shell (refer to Photograph No. 73). Bag expansion against the shell of the restraint produced a single fracture line that extended across the slots for the shoulder belt harnesses. The fracture line radiated from the inboard aspect of both harness slots and extended 2.9 cm (1.9") inboard to a cutout area at the center of the shell (refer to Photograph No. 76).

73. Fractured right side pivot of the infant restraint.

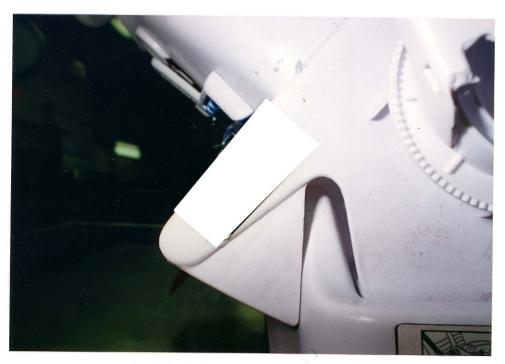
74. Warning label advising against placing the restraint in the right front of a vehicle equipped with a passenger side air bag.

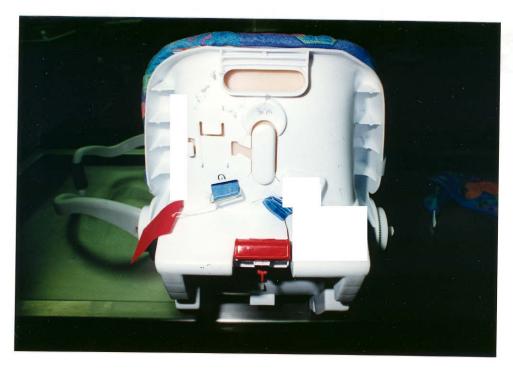
75. Rear view of the Evenflo infant restraint.

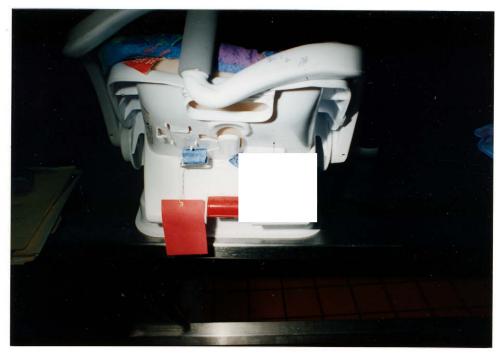
78. Off-set handle configuration in its position at time of deployment.

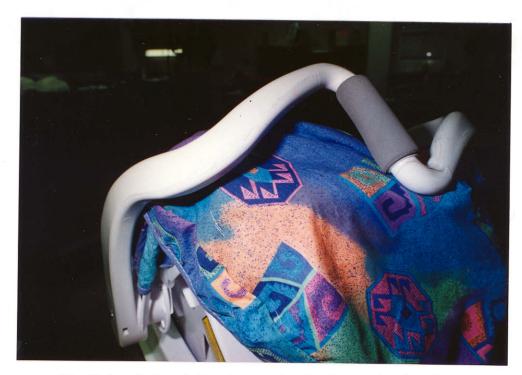
79. Air bag induced abrasions to the plastic carrying handle.

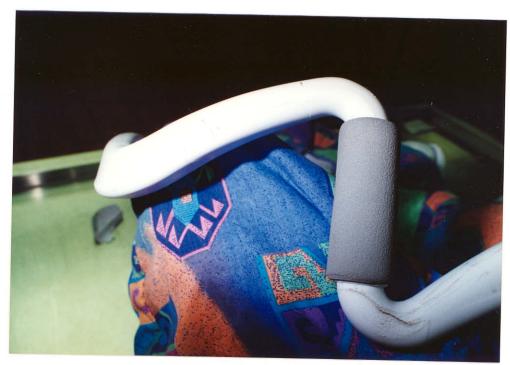
80. Additional view of the abraded carrying handle.

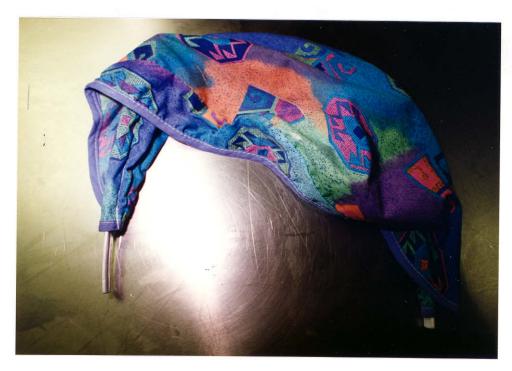
A fabric sun canopy was mounted to the sides of the plastic shell and positioned over the top aspect of the infant restraint. The expansion of the passenger side air bag displaced the canopy from the attachment clips. There was no damage to the canopy (refer to Photograph No. 81).

81. Sun canopy which mounted over top of infant restraint.

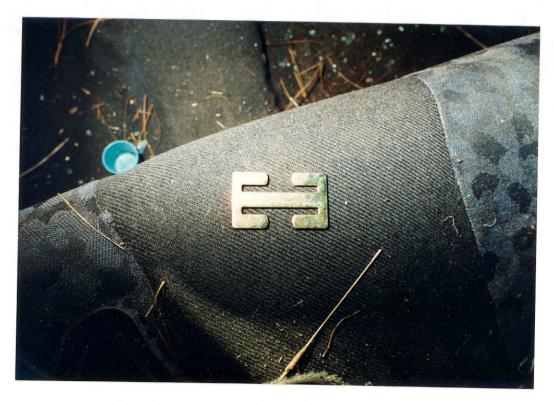
83. Locking clip supplied with infant restraint found on rear seat cushion; unknown if used at time of crash.
